# Navajo Abandoned Uranium Mine Site Screen Report

## **Foutz No. 3 AUM Site**

### **Navajo AUM Eastern Region**

**May 2009**

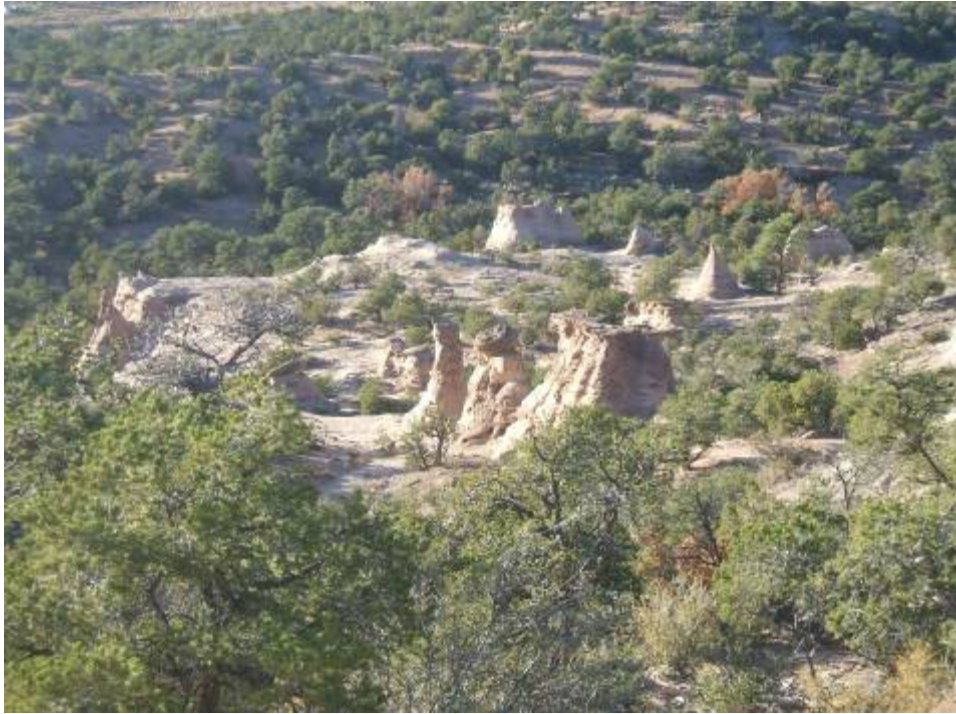
The site has been identified as reclaimed by the NAMLRP, with a reclaimed reference ID of NA-0551, and reclaimed status source of S06220502. No visual signs of reclamation were identified during the site visit. No waste piles, adits or other mine features were observed during the site visit.

Photo 1. Mine site, towards the north/northwest

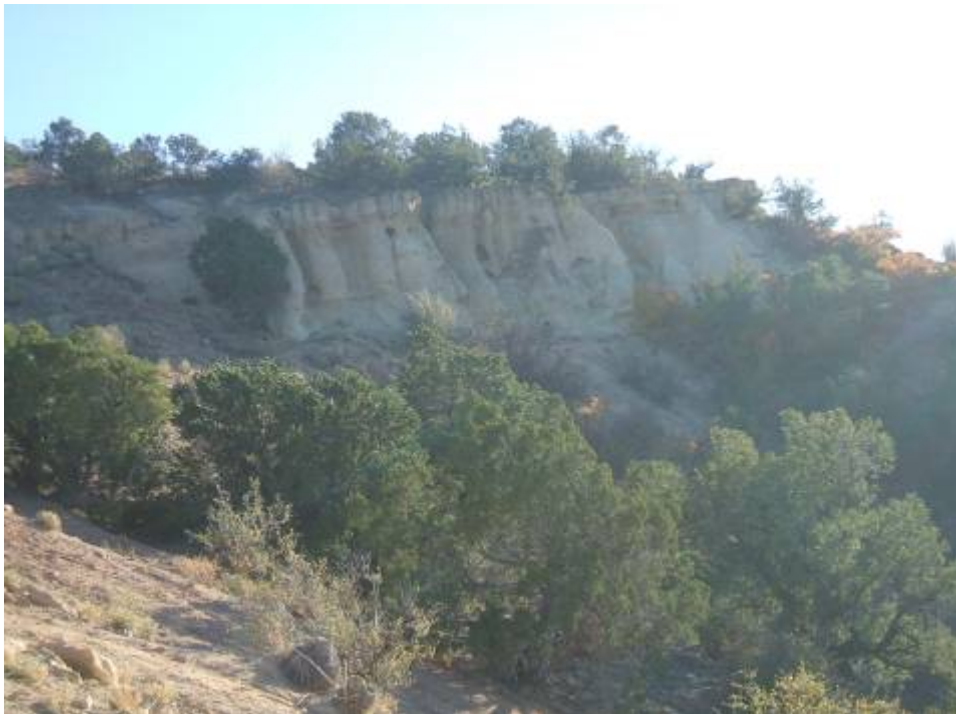
Photo 2. Mine site, towards the south/southwest

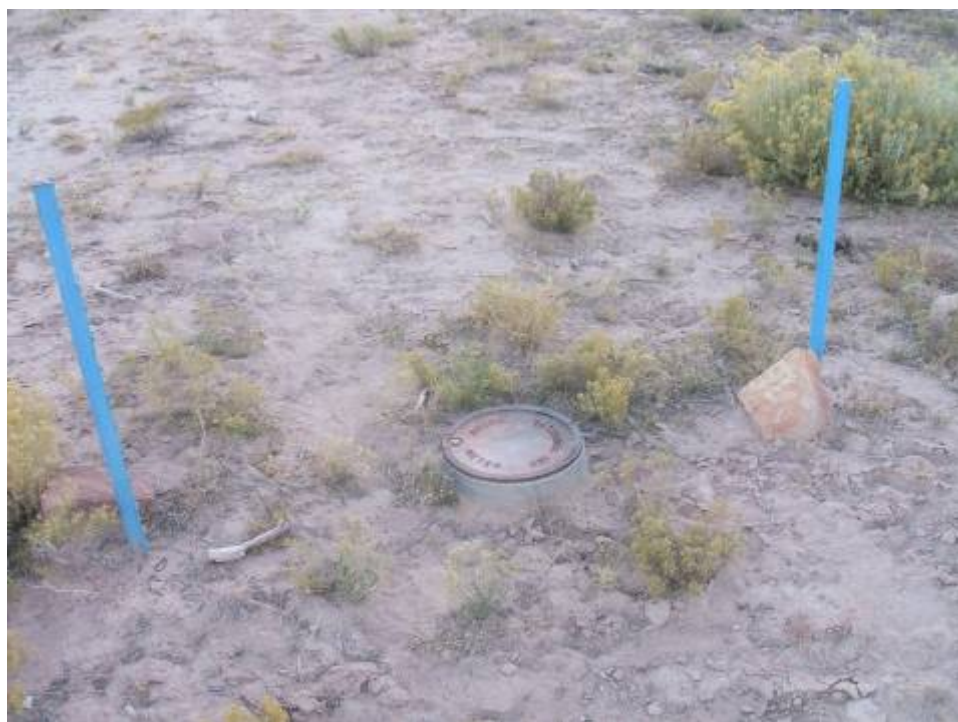
**0 to 0.25 miles:** None                      **0.25 miles to 4 miles:** A well was observed approximately 1 mile west of the site, gamma radiation levels at the well location were found at 15,523 cpm (Photo 3).

A well was observed approximately 1 mile west of the site, gamma radiation levels at the well location were found at 15,523 cpm (Photo 3). The levels at the well are less than 2 times the background levels.

Photo 3. Well, located approximately 1 mile west of the mine site

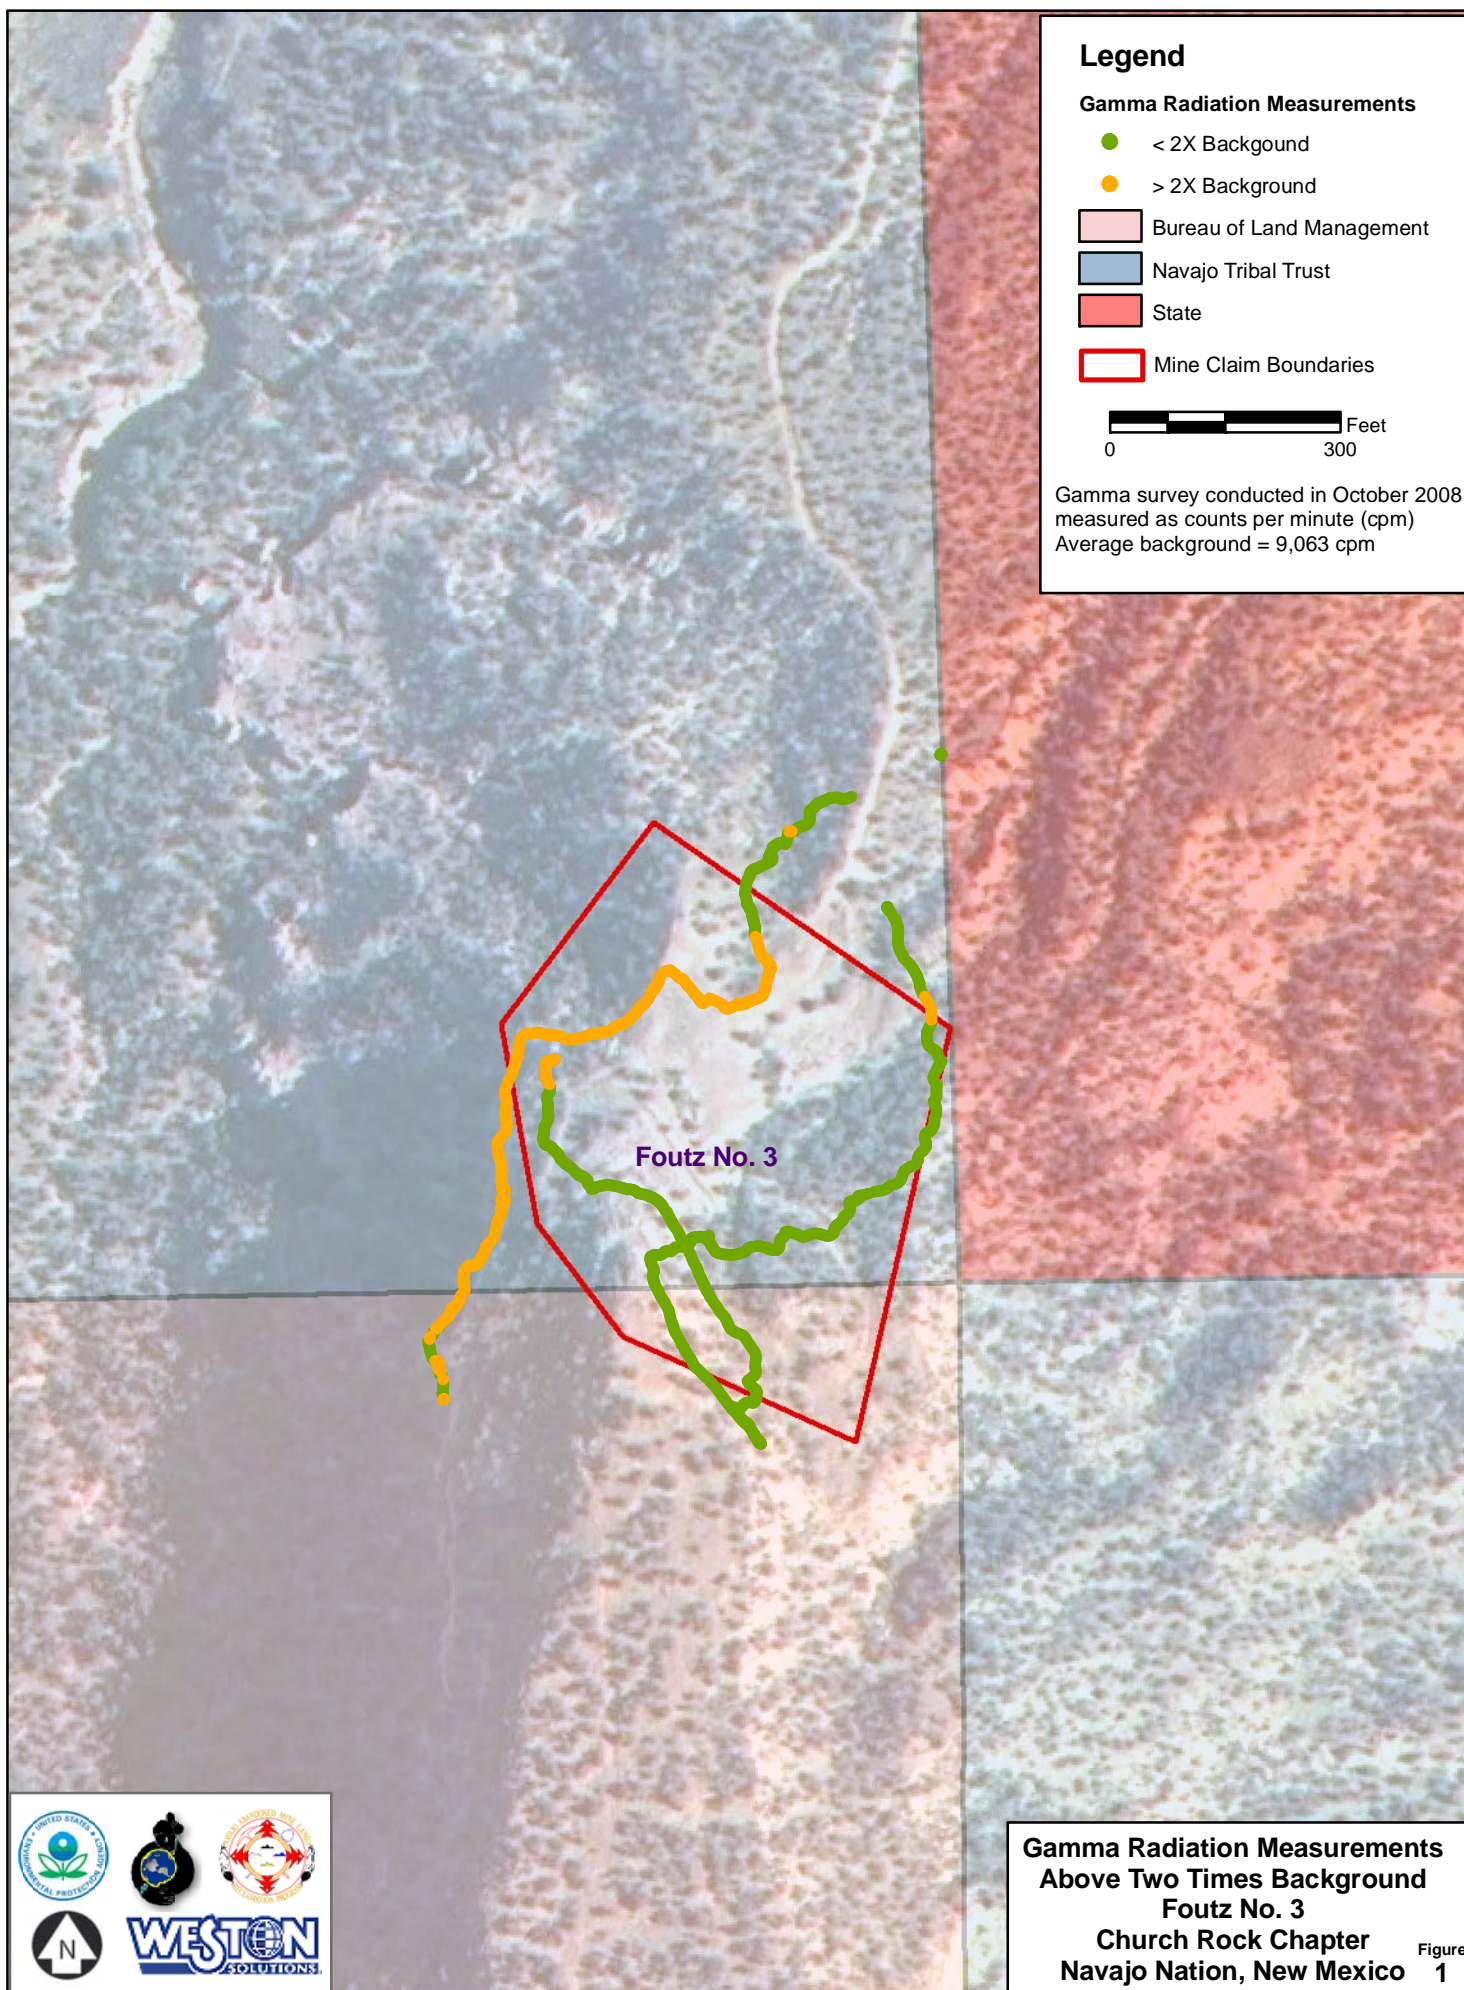
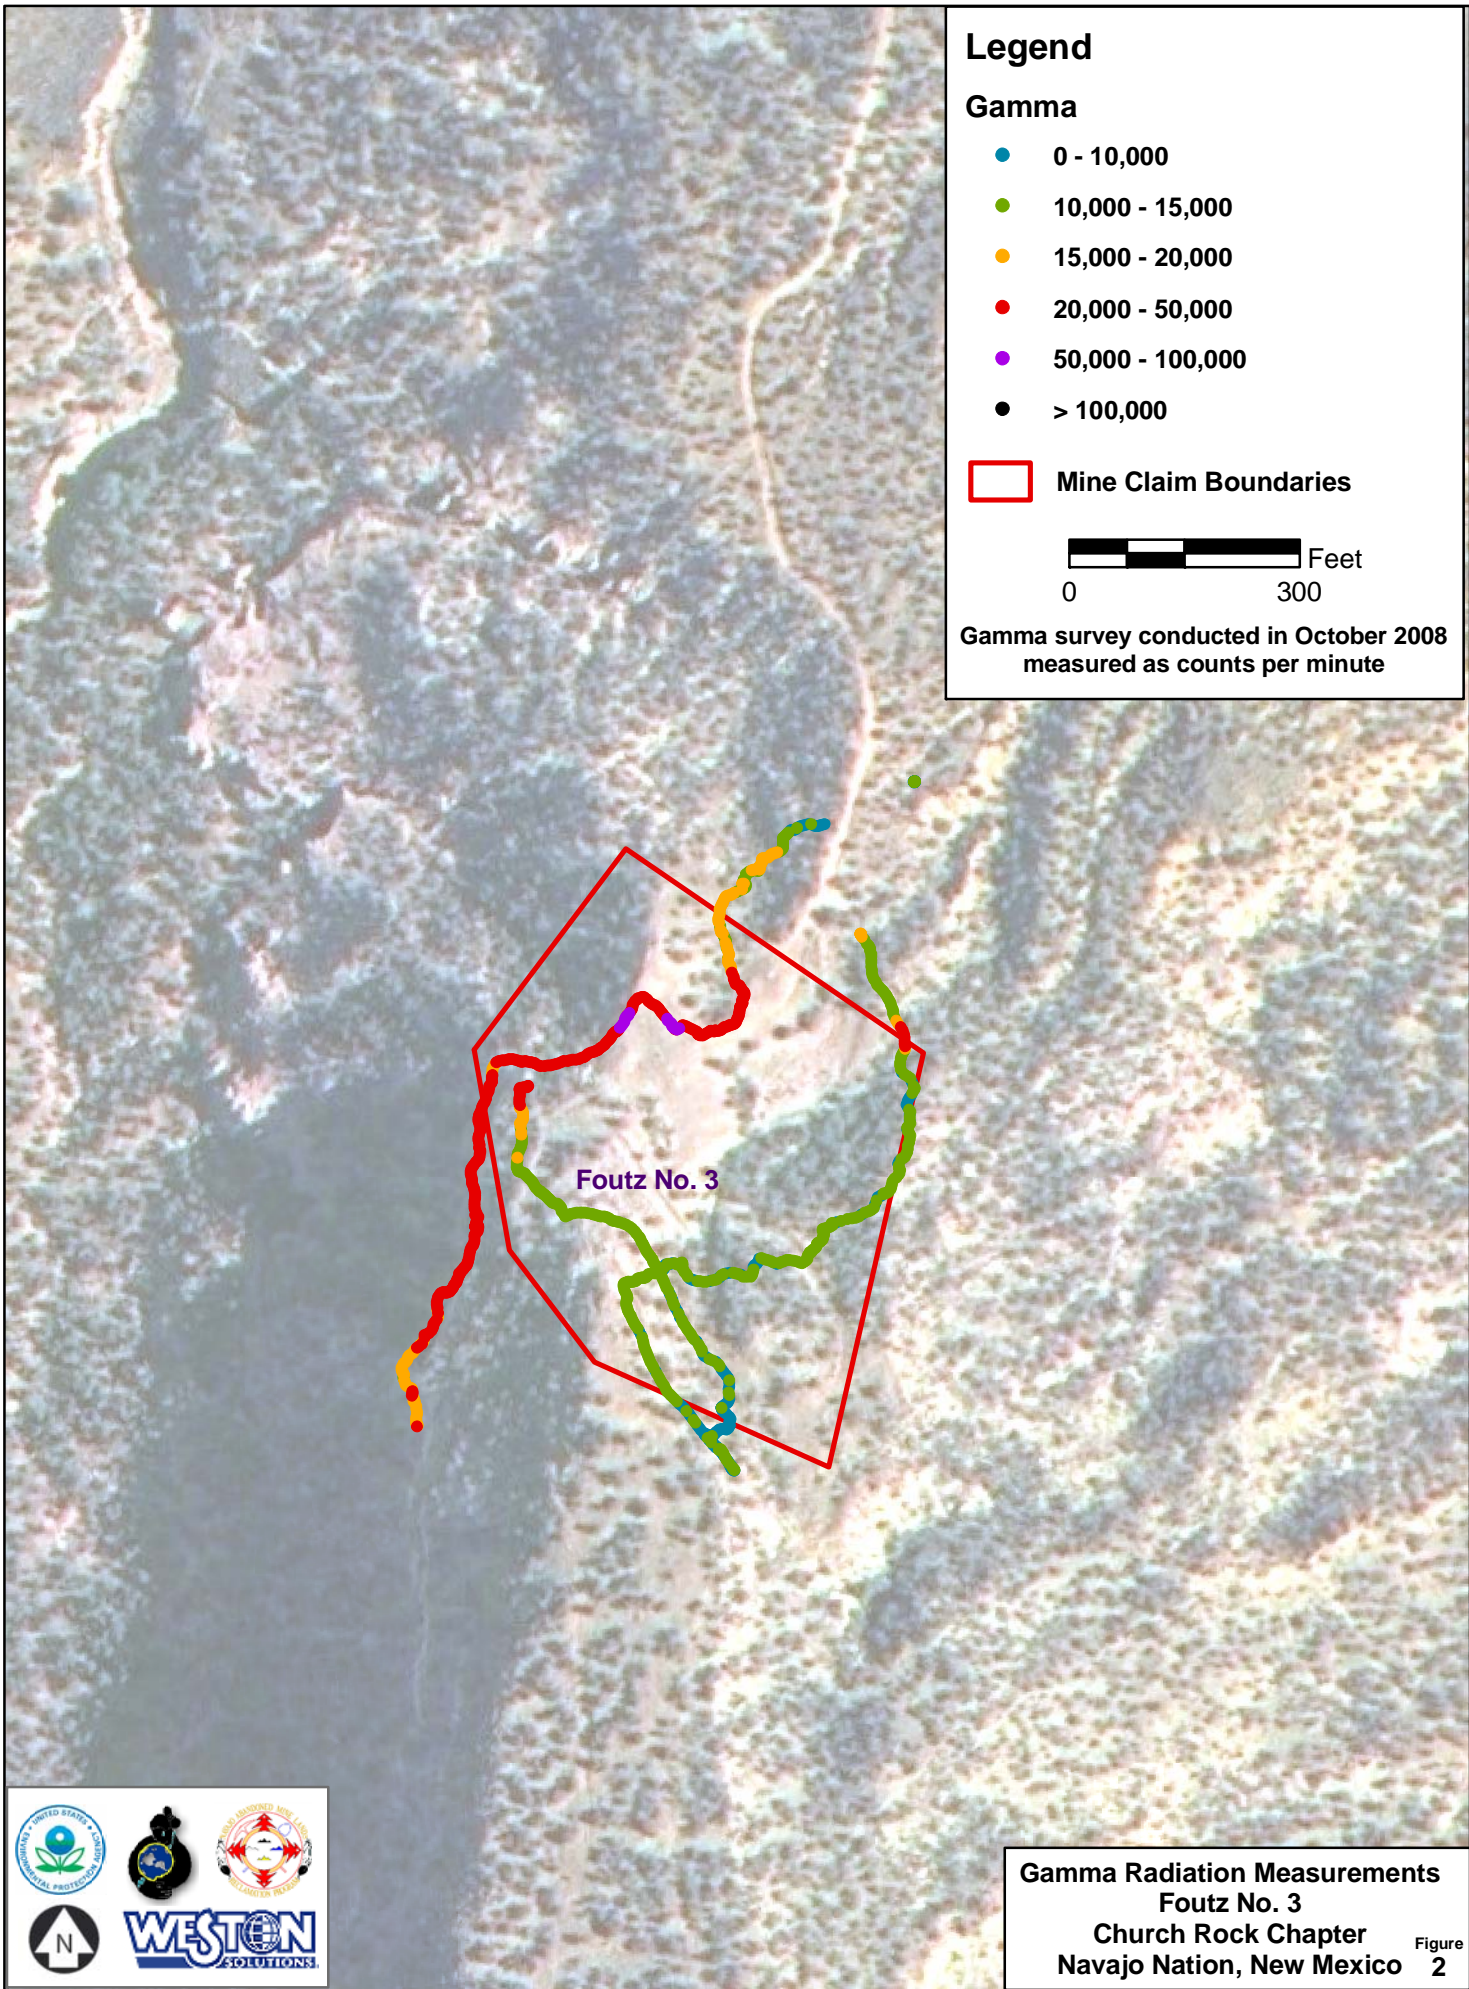
**Gamma Radiation Measurements  
Foutz No. 3  
Church Rock Chapter  
Navajo Nation, New Mexico**

A total of 1,198 gamma radiation measurements were collected from mine sites, ranging from 7,633 cpm to 71,131 cpm. The measurements are represented in Figures 1 and 2.

Gamma survey conducted in October 2008  
measured as counts per minute
